# Hollows Playground and Field

Town of Barnstable  
ADA Transition Plan

August 2021

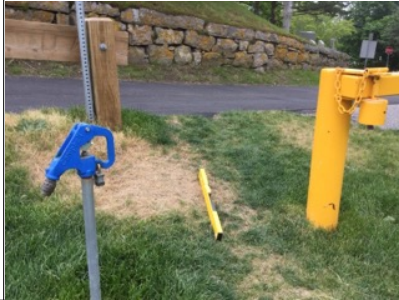
ID	Location	Floor	Room	Element	Type	Photo	Issues	Current Measure	Recommendations	Quantity	Price	Cost Estimation
<b>Approach and Entrance</b>												
<b>Exterior Access Route</b>												
1	Entrance to the Playground and Field	Ext.		Exterior Access Route	Exterior

Running slope > 1:20 (5%) Surface is not stable, firm, and slip-resistant Route not maintained in operable working condition Accessible route not provided	26% - - -	Reduce running slope to be no steeper than 1:20 (5%). Repair surface. Ensure the accessible route is maintained in operable working condition. Ensure an accessible route is provided.  (Cost provided in ID #3.)	1	-	\$0
2	Second Entrance/Exit of Playground (North)	Ext.		Exterior Access Route	Exterior

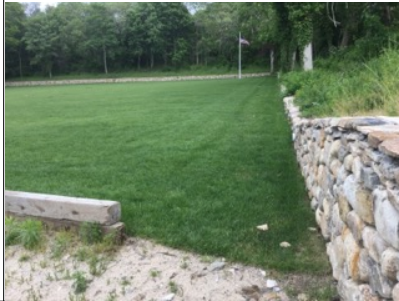
Surface is not stable, firm, and slip-resistant Accessible route not provided	- -	Repair surface. Ensure an accessible route is provided to the baseball field.  (Cost estimate for a 4' wide and 175' long stone dust path.)	1	5600	\$5600

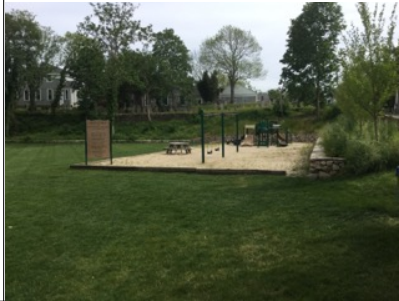
3	Path to Playground	Ext.		Exterior Access Route	Exterior

Accessible route not provided	-	Ensure an accessible route is provided to and around the three sides of the playground that are not bordered by the stone wall.  (Cost estimate for a 4' wide and 165' long stone dust path.)	1	5280	\$5280
<b>Access to Goods and Services</b>												
<b>Picnic Tables</b>												
4	Playground	Ext.		Picnic Tables	N/A

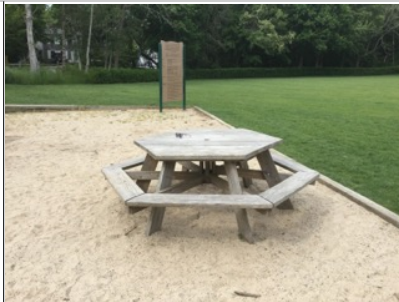
Toe or knee clearance at table not provided Picnic table not on an accessible route	- -	Provide at least one picnic table with top between 28"- 34" above the ground and 27" clear height underneath. Ensure that the dining surface is connected to an accessible route.	1	1400	\$1400
<b>Play and Sport Areas</b>

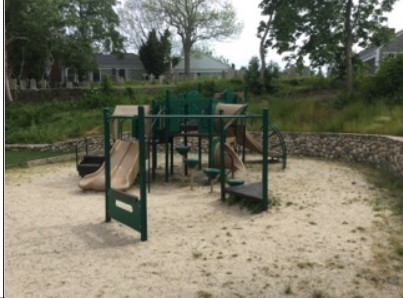
ID	Location	Floor	Room	Element	Type	Photo	Issues	Current Measure	Recommendations	Quantity	Price	Cost Estimation
<b>Play Areas</b>												
5	Playground	Ext.		Play Areas	N/A

Accessible route not provided at play components	-	Provide a compliant impact-attenuating surface under and around the play components  (Cost estimate for 1500 sq. ft. of poured in place rubber surface.)	1	21000	\$21000
